NASA CR-134531

EXPLORATORY DEVELOPMENT OF A GLASS CERAMIC AUTOMOBILE THERMAL REACTOR

by R. E. Gould and R. W. Petticrew
(NASA-CR-134531) EXPLORATORY DEVELOPMENT
OF A GLASS CERAMIC AUTOMOBILE THERMAL
REACTOR (Owens-Illinois, Inc.) 33 p HC
\$3.75

Owens-Illinois, Inc.
Toledo, Ohio 43666

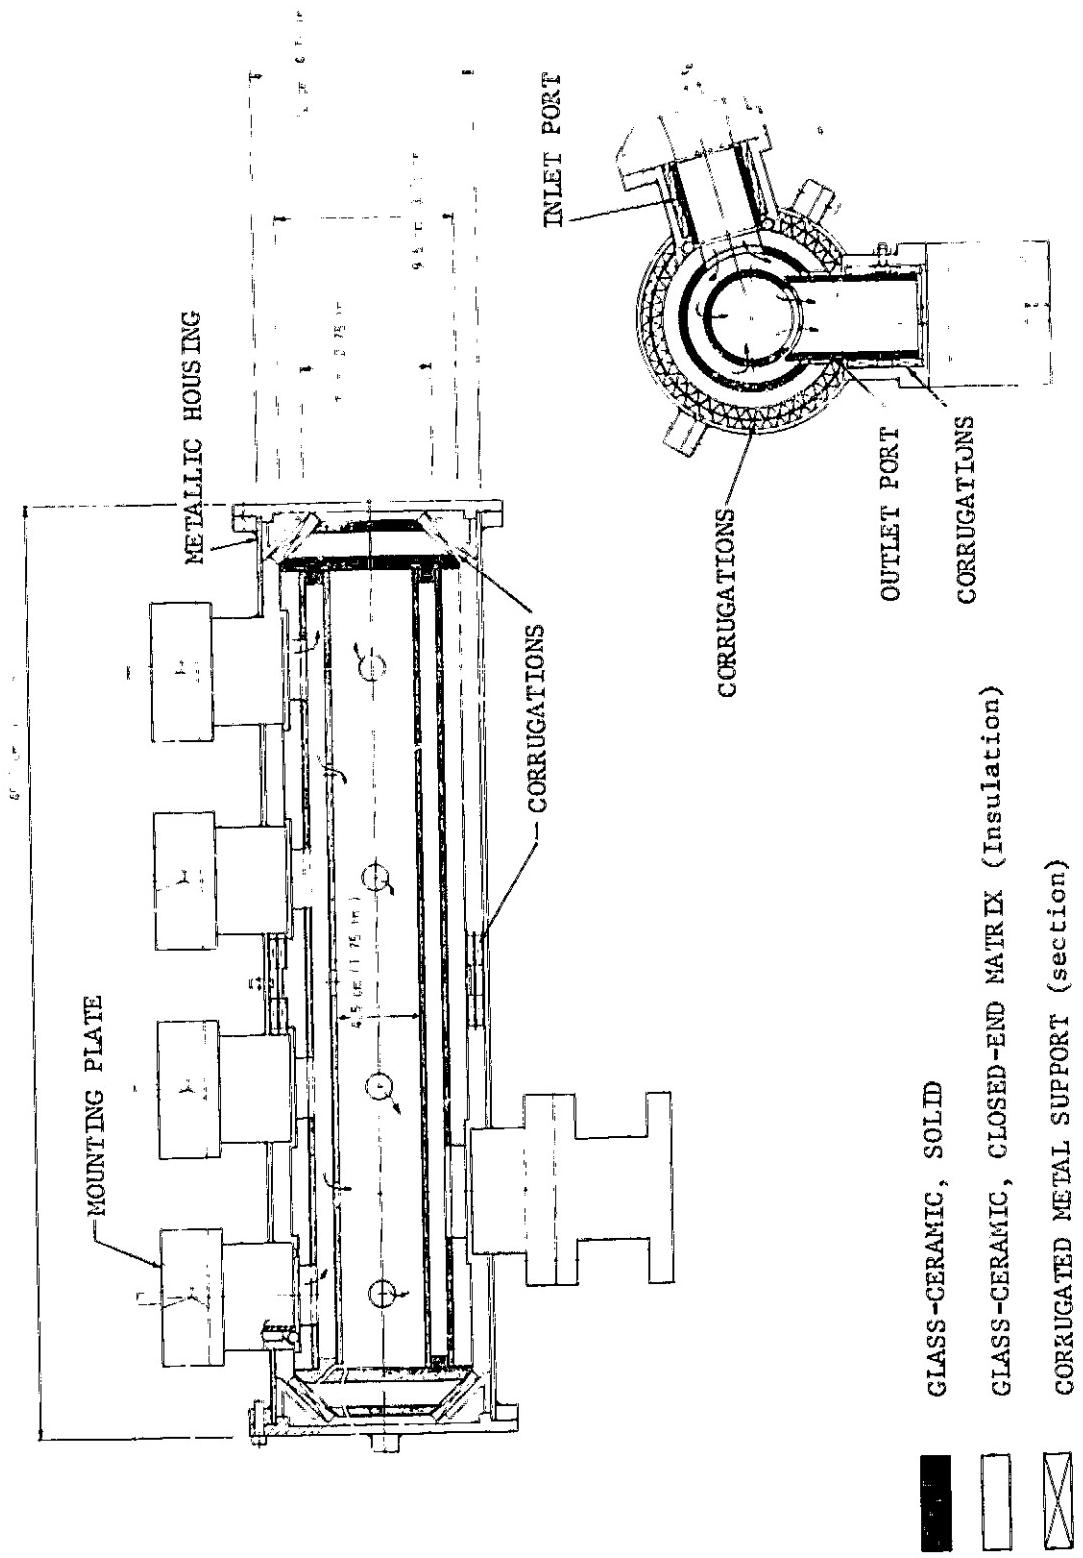
Figure 3 Glass-ceramic thermal reactor, Design III

Testing of Modified Reactors - A modified Design II and a Design III reactor were delivered to Teledyne and placed on test. The Design III reactor immediately developed a hot spot, and upon examination, it was discovered that the outer pipe contained a large solid inclusion which had caused it to fail quickly due to thermal expansion differences. A replacement Design III reactor was fabricated and put on test along with the modified Design II reactor. The temperatures of these reactors were monitored and control was maintained by a thermocouple extending into the reactor outlet port. At the end of approximately $2\frac{1}{2}$ cycles (85 hours), it was observed that a crack had developed in the Design III reactor and it was removed from test. Examination of this reactor revealed that the resilient mounting had relaxed enough to allow the glass-ceramic main body to move. Once relative motion was permitted between the housing and the reactor core, failure became imminent.

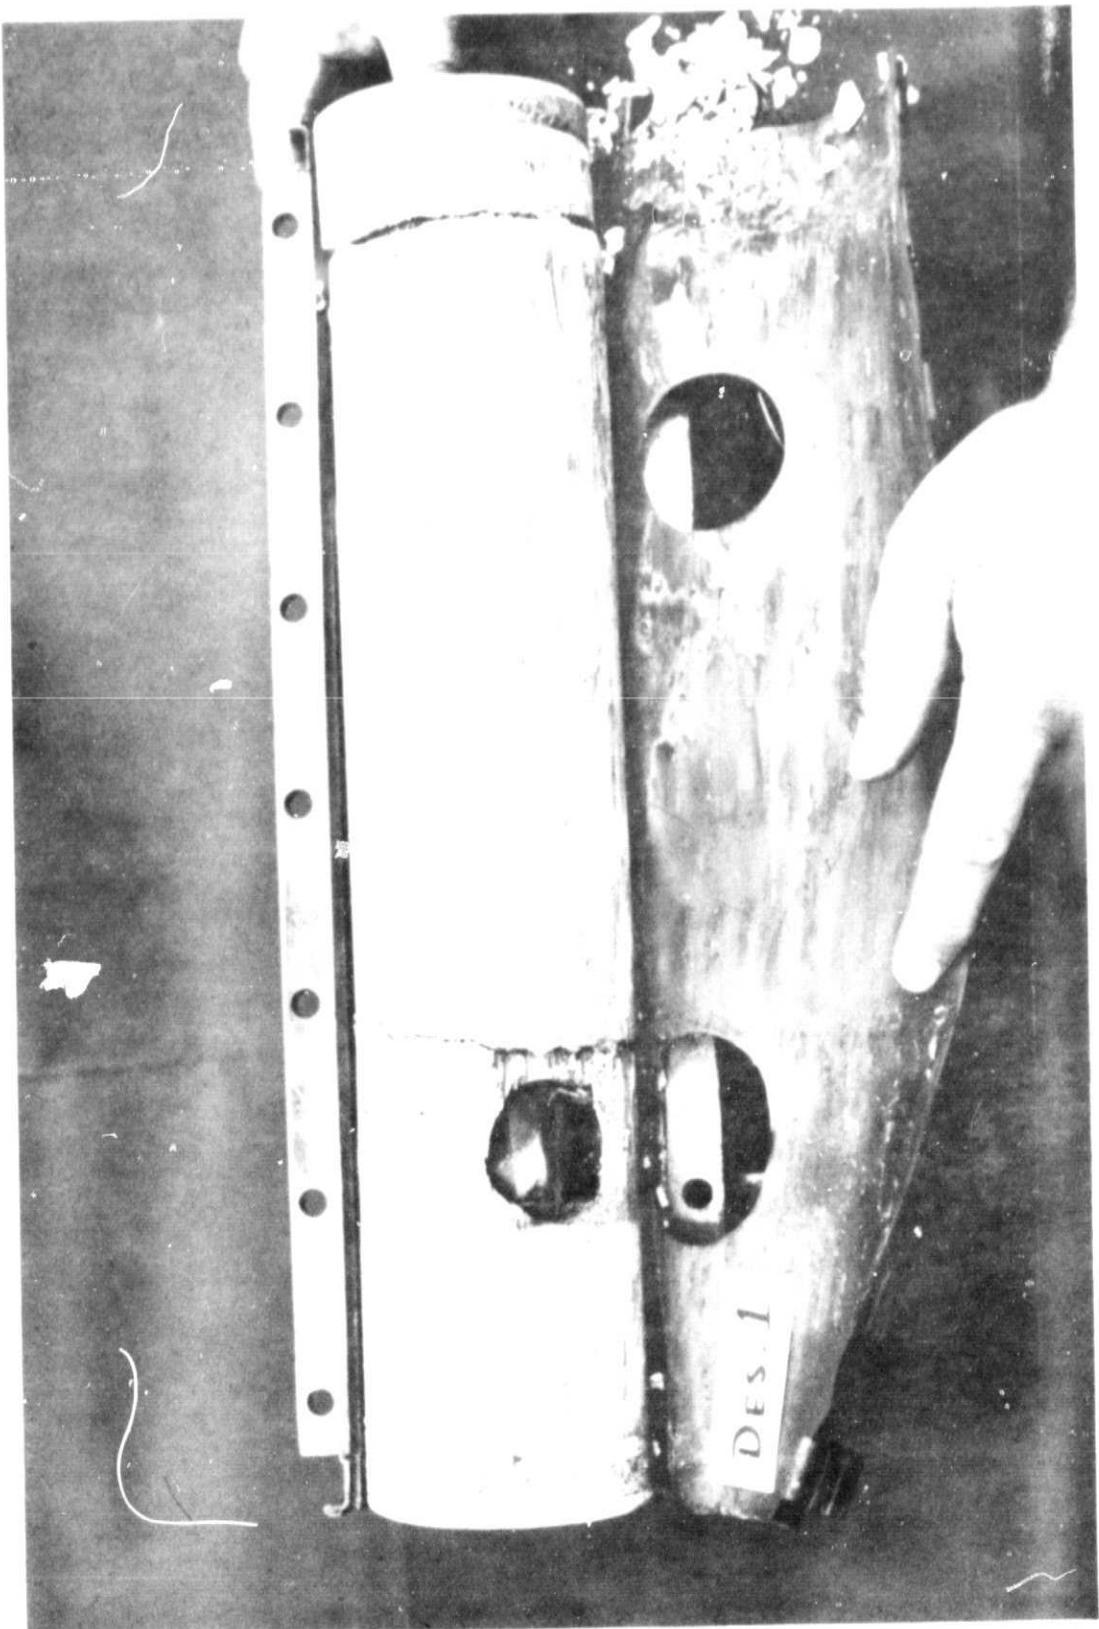
Figure 14 Breakage of glass-ceramic main body (REACTOR R-6)

Preliminary Testing - Figure 12 shows one of the two reactors (one Design I and one Design II) subjected to the endurance test cycle. Figure 13 shows the locations of the thermocouples which were used to monitor temperatures during the thermal endurance testing. These reactors were mounted on one of three Ford 495×10^{-3} meter³ (302 cu. in.) V-8 test engines. The reactors were run through one complete cycle of approximately $32\frac{1}{2}$ hours, and the engine was shut down for reactor inspection. Upon removal from the engine both reactors were found to be broken. The reactors were returned to Owens-Illinois and disassembled. Photographs were taken of each step to aid in the analysis of the causes of failure. The analyses indicated that in each case, reactor failure had originated with the failure of a ceramic inlet port. This permitted exhaust gas to bypass the reactor cores thus creating hot spots along the reactor housings. Since the housings were securely fastened to the engine head, they could only expand in a plane parallel to the plane of mounting. As a result, the housings undoubtedly bowed and broke the glass-ceramic main bodies due to the bending forces on them. The reactor breakage of the Design I main body is shown in Figure 14. During the failure analysis, it was also noted that small particles of broken glass-ceramic had jammed into many of the open matrix passageways. This would have caused an increase in back pressure, further increasing the amount of gas bypassing the reactor core, and thus further increasing housing temperatures and bending forces.

Several of the remaining ceramic ports appeared to have been "hammered" as evidenced by chipping on the periphery of the ends toward the engine. It was believed that the metal flanged retainer plates, which were supposed to hold in place the corrugations surrounding the ports (and consequently the ports), had in several instances moved enough beneath their gaskets to contact and vibrate against the ceramic ports. It was therefore concluded that the two totally broken ports had failed due to the above cause. It was apparent that the port areas had to be redesigned. In addition to the conclusion concerning the port areas, it was also concluded that the Design I reactor which used matrix material for a gas passage was overly vulnerable to passage blockage by any foreign material which might enter the reactor.

<u>Reactor Number</u>	<u>Ceramic Material</u>	<u>Design Type</u>	<u>Time in Test, h</u>	<u>Results of Visual Examinations</u>
R-6	Glass-Ceramic CER-VIT C-129	Type I	30	Inadequate corrugation support at temperature: thermal cycling and engine vibration led to cracked ceramic parts.
R-7	Same as R-6	Type II	35	Same as for R-6
R-10	Same as R-6	Type II	330	Same as for R-6
R-12	Same as R-6	Type II	255	Same as for R-6
R-13	Same as R-6	Type III	85	Same as for R-6

As a result of the failure analyses, the Design I reactor was discontinued due to reasons given above, the Design II reactor was modified and the Design III reactor was introduced.

For the modified Design II and the Design III reactors the ceramic port areas were redesigned to eliminate all flat gaskets and metal flanged retainer plates. The seal around the ports was made by using gaskets of carbon impregnated asbestos around an Inconel spring. The housings were changed from stainless steel to low carbon steel to reduce bending stresses due to thermal expansion. The metal corrugations around the glass-ceramic main bodies for radial support was increased from one to two layers and the housing diameter increased concurrently. The corrugation sites, however, were reduced to about one-third that for the original Design II. Finally, a glass-ceramic "band" was bonded around and at the center of the main bodies for lateral location.
